# On the Seismic Response of School Buildings in Van: A Closer Look to the Collapsed Gedikbulak School

## Gedikbulak Primary School

- The primary school of Gedikbulak, built in 80's, collapsed during the October 2011 Tabanlı Earthquake of Mw=7.2
- There was a student meeting which ended some minutes before the shaking, thus luckily there were no fatalities
- The building has totally collapsed

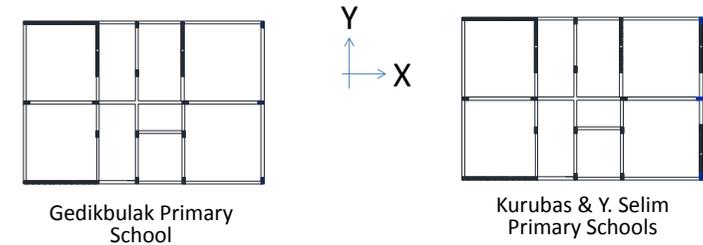
- The design of Gedikbulak was done by 1975 Turkish Earthquake Code (above-left)
- In 1998, the design was improved and modified to comply with the 1998 Code (above-right)

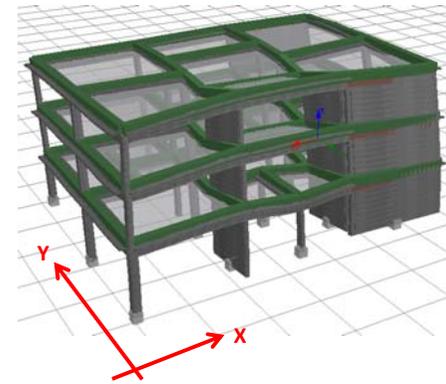
## Model and the 1st Mode Shape

T1=0.23sec (69% contr. in Y)  
T2=0.16sec (60% contr. in Rz)  
T3=0.15sec (55% contr. in X)

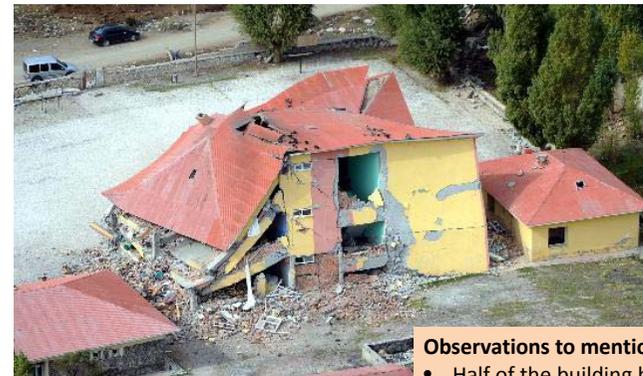
## Collapse of the School Building

### Observations to mention are:

- Half of the building has collapsed in pan-cake shape
- The RC walls, though quite large, they still failed at the ground floor
- The RC walls have moved from their axes

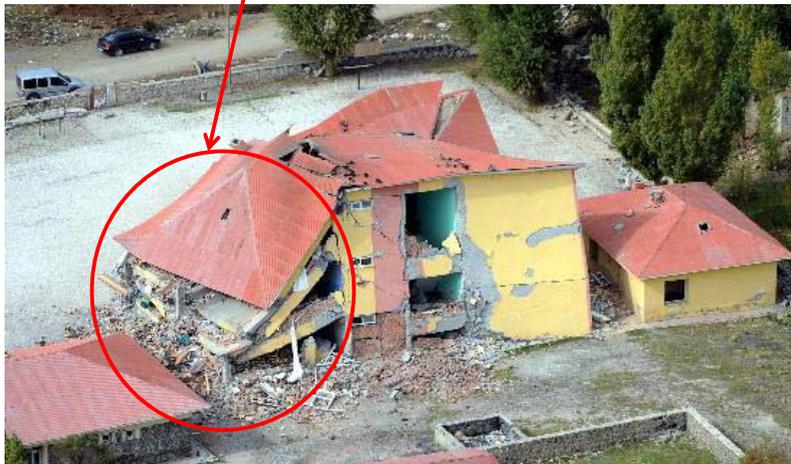
### Collapse of the School Building

We cannot catch this with orthogonal loading
