# On the Seismic Response of School Buildings in Van: A Closer Look to the Collapsed Gedikbulak School

## Gedikbulak Primary School

- The primary school of Gedikbulak, built in 80's, collapsed during the October 2011 Tabanlı Earthquake of Mw=7.2
- There was a student meeting which ended some minutes before the shaking, thus luckily there were no fatalities
- The building has totally collapsed

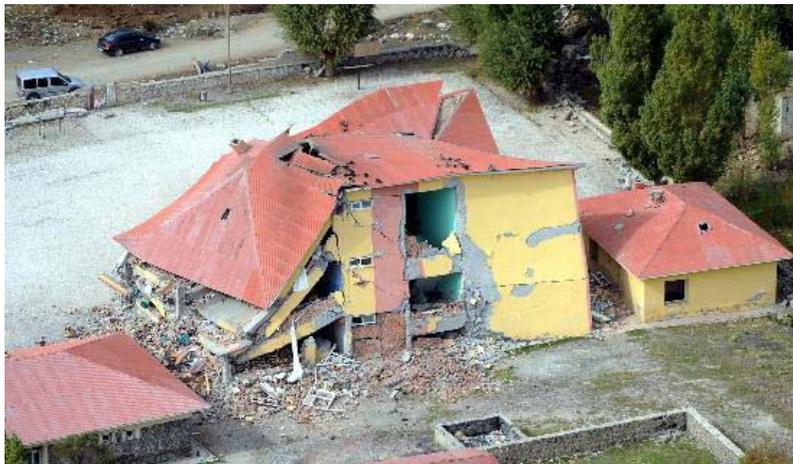
## Collapse of the School Building

- Half of the building has collapsed in pan-cake shape
- The RC walls, though quite large, they still failed at the ground floor
- The RC walls have moved from their axes

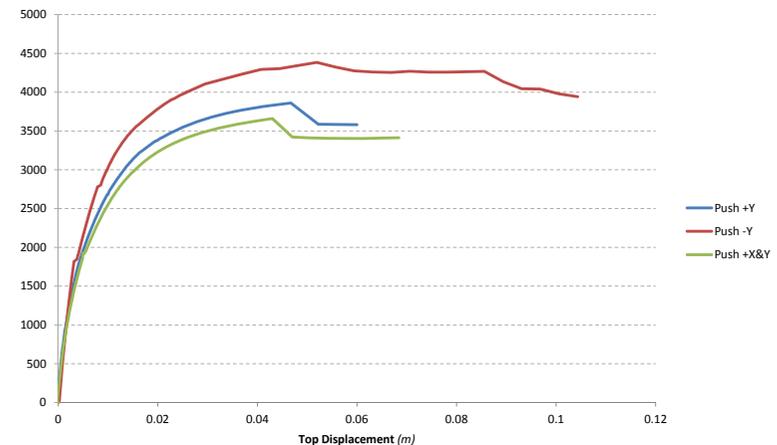
# Capacity Curves

- The bearing system of the Gedikbulak Primary School is quite strong with very long RC walls, thus the reasons behind the collapse need to be investigated with care
- In structures where T or C-shape RC walls are dominating the response, the capacity curves in opposite directions may be asymmetric, something that is not much examined in the existing assessment codes
